# Technical finding

## Terminal L2 insulation

Distribution cabinet RH-01

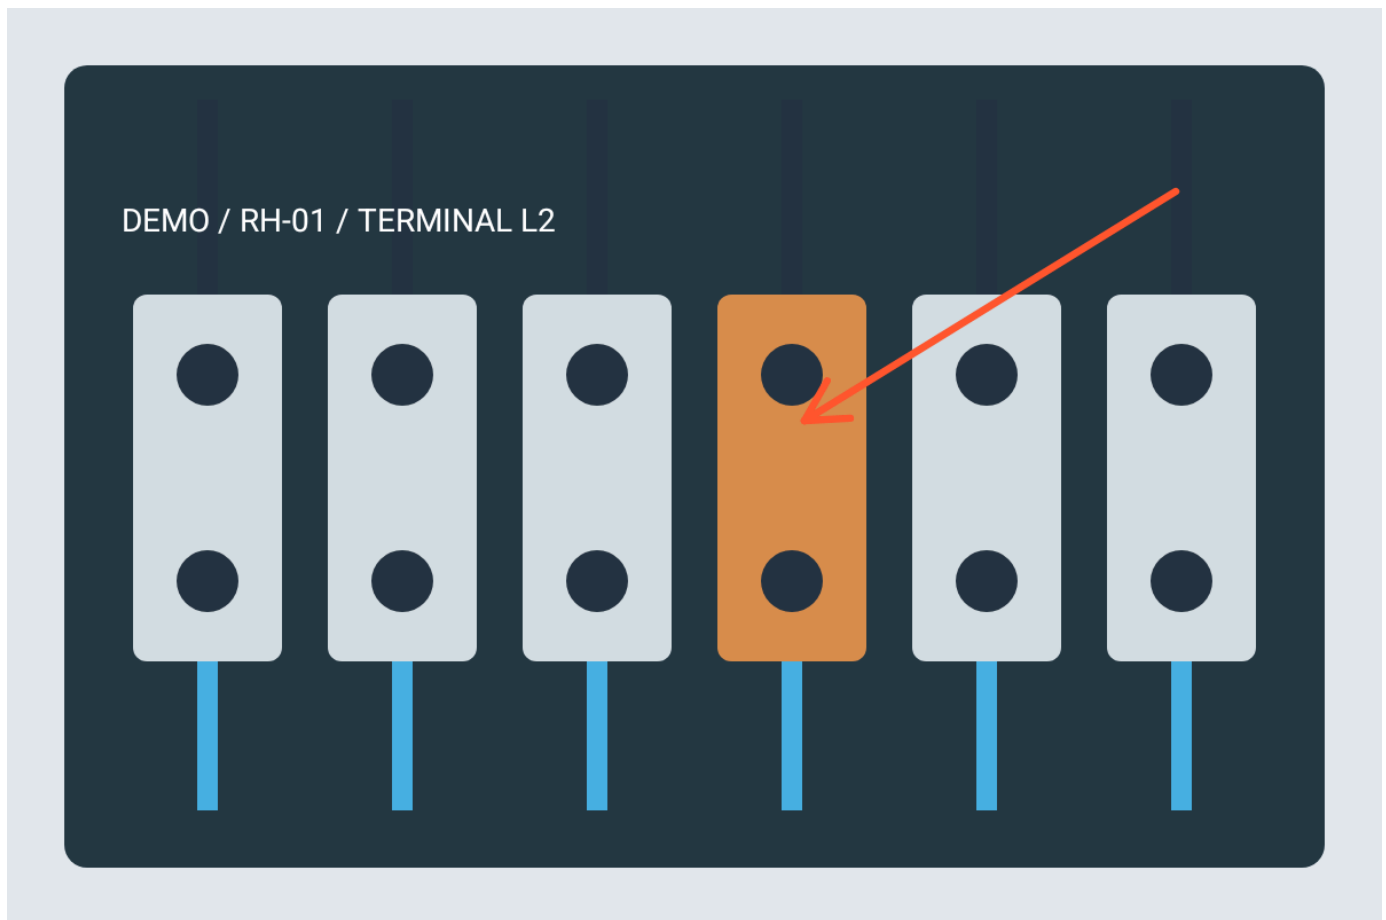
Terminal L2 / photo 1

High

Visible insulation damage near terminal L2. Cause not yet established.

Qualified inspection of the connection and conductor; measurements according to the findings.
